**ASBESTOS AND LEAD BASED PAINT  
SURVEY**

*Project Site:*  
**OMC Plant 2**  
**100 East Sea Horse Drive**  
**Waukegan, Illinois**  
*Project # 1515.007.01*

December 14, 2007

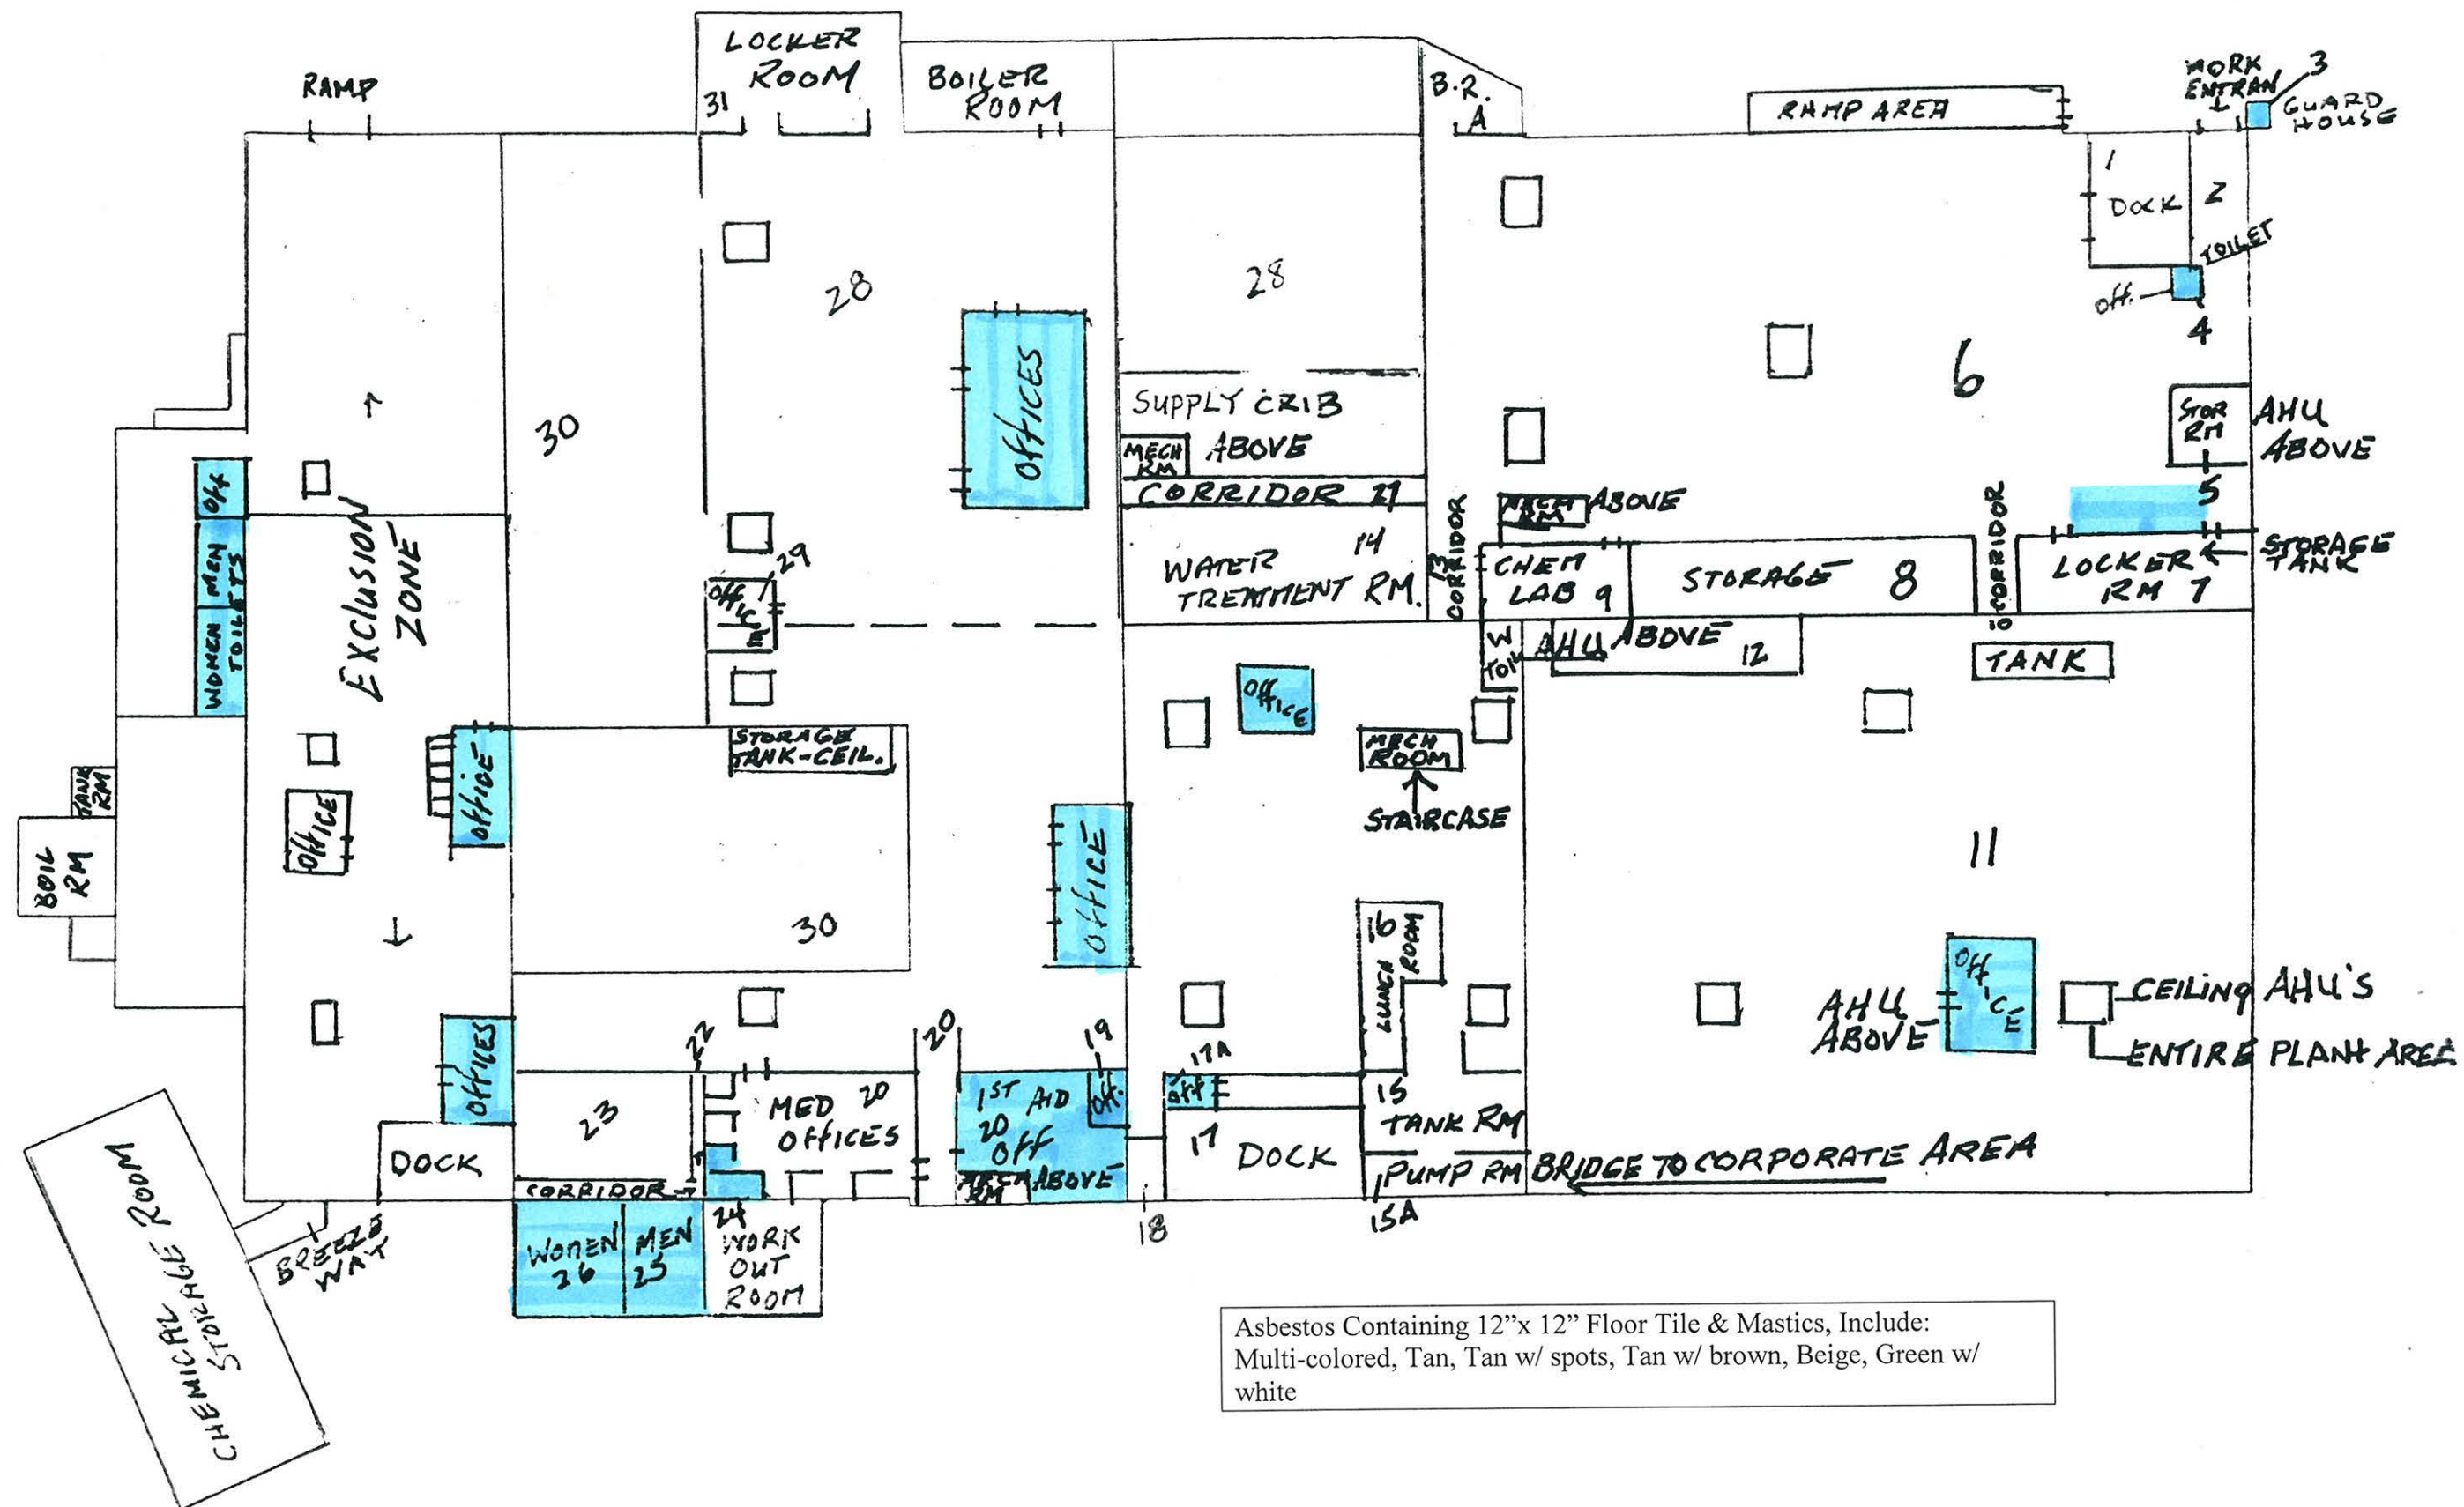
FIG. *ASB-2*

Asbestos Containing 12"x 12" Floor Tile & Mastics, Include:  
Multi-colored, Tan, Tan w/ spots, Tan w/ brown, Beige, Green w/  
white
